Lessons Learned from Dike Failures in Recent Decades

ABSTRACT: *The paper describes five different dike failures that occurred in recent decades. The case histories were located on different rivers and involved different loading conditions. The observed failure mechanisms involved erosion and stability problems. The types of erosion observed were both internal erosion due to extreme groundwater flow and external erosion caused by the river flow and wave action. The case involving instability was caused by uplift, i.e., increased hydraulic head led to a sharp reduction in maximum shear strength between subsoil layers. Two cases demonstrate the importance of dike management and maintenance. Despite the variations in the loading conditions and failure mechanisms, all the cases show that the strength of a dike depends not only on the material used to build the dike but also on the strength of the subsoil.*

Lessons Learned from Dike Failures in Recent Decades. International Journal of Geoengineering Case histories, Vol.4, Issue 3, p.203-229. doi: 10.4417/IJGCH-04-03-04

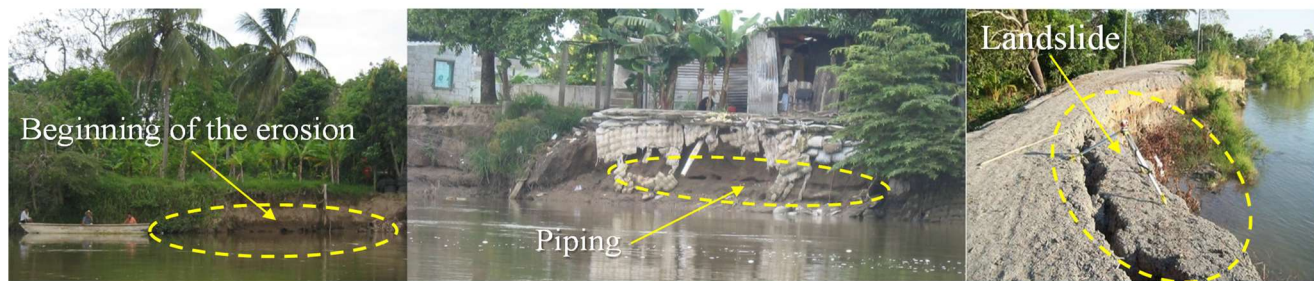
Sudden or rapid drawdown occurs when there is an unexpected drop in the outside water level that modifies the flow conditions in the structure without adequate time for drainage of the soil mass. Hydraulic gradients and seepage forces develop that, in extreme conditions, cause soil erosion problems that range from minor to severe, examples being piping or even the complete failure of the structure. In addition, rapid drawdown has a negative effect on slope stability and it may result in the

Figure 4. Evidence of instability in river banks and dikes induced by rapid drawdown in Villahermosa.

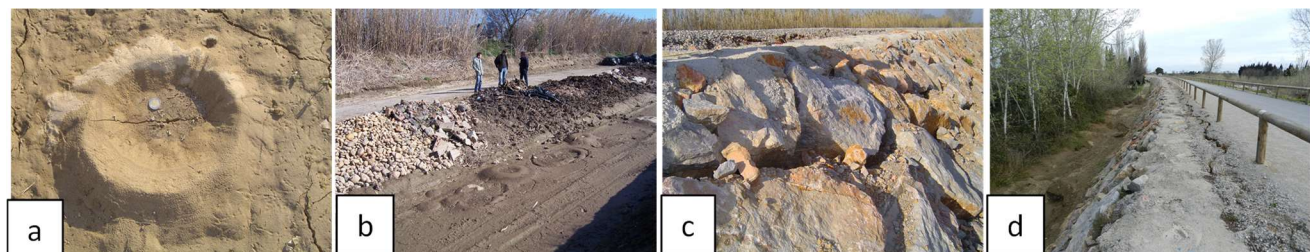
This was also a moderate event: about 800 m³/s at Rivesaltes. However, it lasted longer: 18 hours rather than the 12 hours in the November 2005 event. The dikes were loaded up to 1/2 to 2/3 of their height. CEMAGREF quickly conducted an inspection of a section of 500 m which had been identified in 1999 as being prone to sand boils. A recommendation had been made to install a drainage and seepage system on the landward side. Some of this work had been completed in 2000 with supervision from the managing authority at the time (an association of local authorities). During the winter of 2004-2005, the landward side of the dike was reinforced with concreted riprap to render it resilient to overtopping. During the 2006 event, a section of 130 m in the same location suffered damage caused by internal erosion in the form of sand boils (Figures 13a, b) and subsidence over a strip of up to 1-2 m wide in the protected plain close to the dike, including the maintenance track, and cracking of the concreted riprap (Figures 13c, d).

Figure 13. a) Sand boil (photo: Pierre Philippe, CEMAGREF), b) Multiple sand boils close to the maintenance track on the landward side of the dike (photo: Patrice Mériaux, CEMAGREF), c) Damage to the dike itself: cracks on the crest and in the riprap landside revetment (photo: Pierre Philippe, CEMAGREF), d) Damage to the dike itself: crack on the crest; this picture was taken in 2013 but similar damage occurred in 2006 (photo: Patrice Mériaux, Irstea).

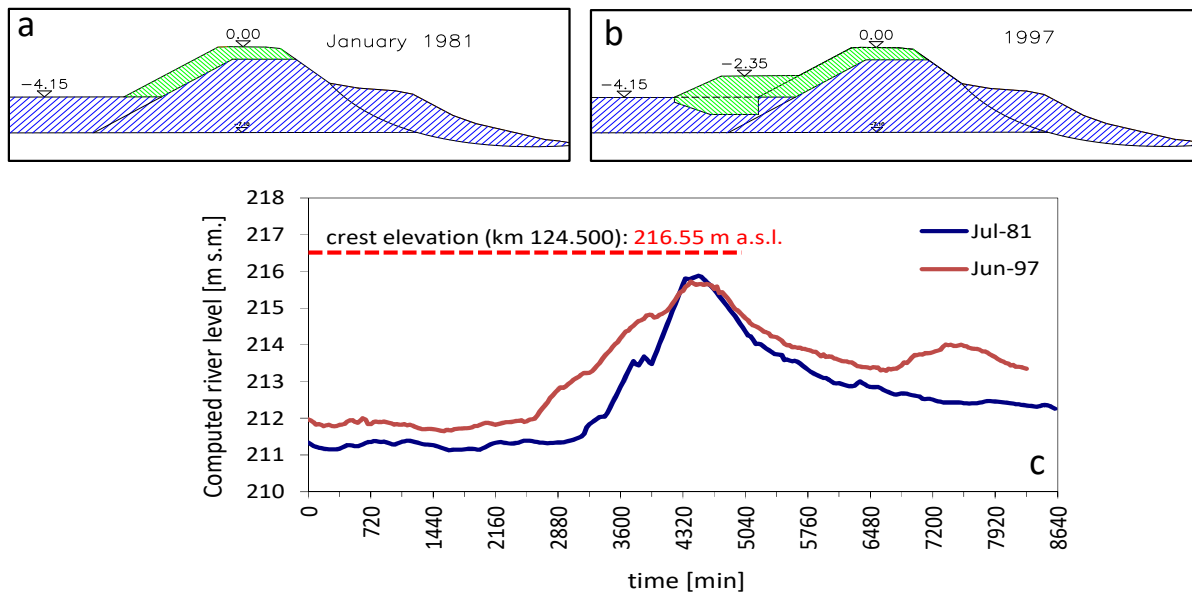
During the flood event in 1997, which was even more intense than the one in 1981 (Figure 19c) no collapse phenomena were observed in the segments that had experienced instability in 1981. This can be attributed to the construction of the berm and the increased stability on the landward side.

Figure 19. a) cross section during the flood event in 1981 b) remedial works consisting of a berm on the landward side, c) the river level during the flood events in 1981 and 1997 The elevation of the embankment crest is also reported as a reference.

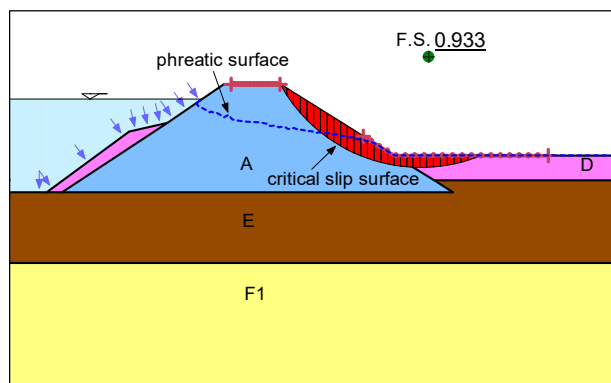
Figure 24. Stability analysis and relevant soil parameters at flood peak and transient flow condition of the section at km 124.62 in Laag; $c' = 0 \text{ kN/m}^2$

where σ_n is the normal stress, θ_w is the volumetric water content, θ_s is the saturated volumetric water content and θ_r is the residual volumetric water content. The results of the stability analyses at flood peak for the two cross-sections based on transient flow conditions are shown in Figures 24 and 25. The stability analysis consistently returns factors of safety < 1 for these sections, which proved to be unstable in 1981.

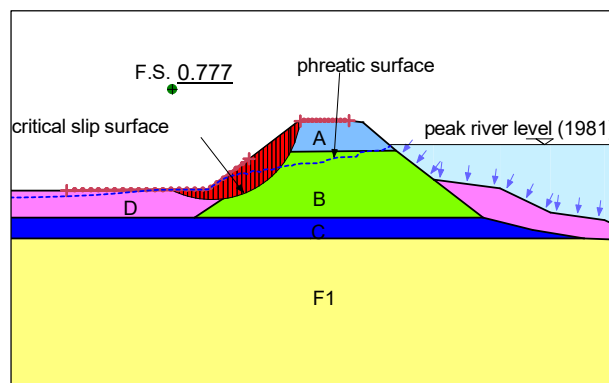
Figure 25. Stability analysis and relevant soil parameters at flood peak and transient flow conditions of the section at km 122.248 in St. Florian; $c' = 0 \text{ kN/m}^2$.

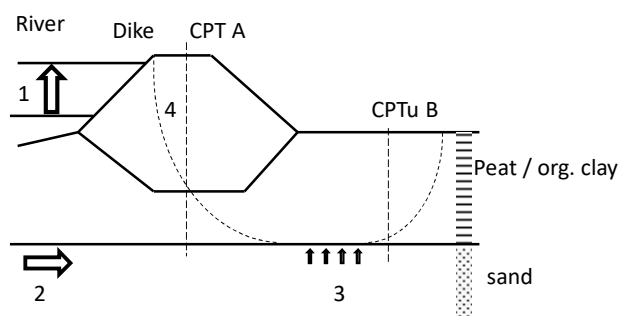
Figure 28. Impression of the uplift failure mechanism, 1: river level rise, 2: hydraulic connection to sand layer, 3: pore pressure rise until uplift top layer, 4: failure plane.

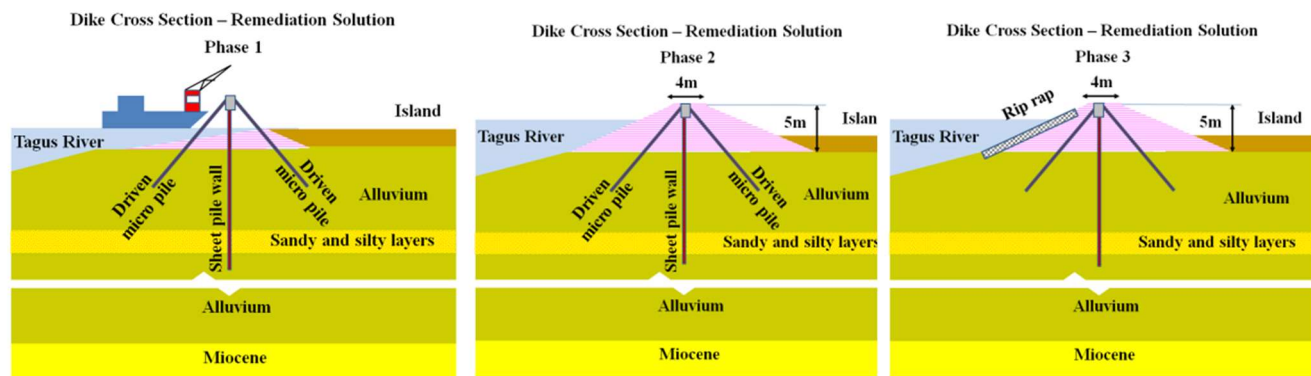
Figure 41. Dike remediation: main construction phases.

The proposed dike remediation solutions comprised the use of a driven sheet-pile wall braced by inclined driven steel micro-piles, all capped with a top and a central, reinforced, concrete beam. Those works are to be performed from a barge at high tide. The depth of the sheet pile walls will have to be enough to pass through the silty and sandy alluvial layers. A protection and stabilisation fill will be required on both the outer and inner sides of the sheet piling. On the outer face of the fill, a riprap protection revetment will be required to protect the fill from hydraulic erosion. Figure 41 illustrates the reconstruction works.
